BOARD OF INQUIRY REPORT
LADDER COMPANY 26
INC# 09-1897
JANUARY 9, 2009

Report on: The Fatal Motor Vehicle Accident Involving Ladder Co. 26
Incident # 09-001897
25 Mission Park Drive
Roxbury, MA
District 5, Division 2

Fire Commissioner Roderick J. Fraser Jr. appointed a Board of Inquiry on January 15, 2009 to investigate the circumstances surrounding the death of Fire Lieutenant Kevin M. Kelley, Ladder Company 26 Group 4, which occurred on January 9, 2009.

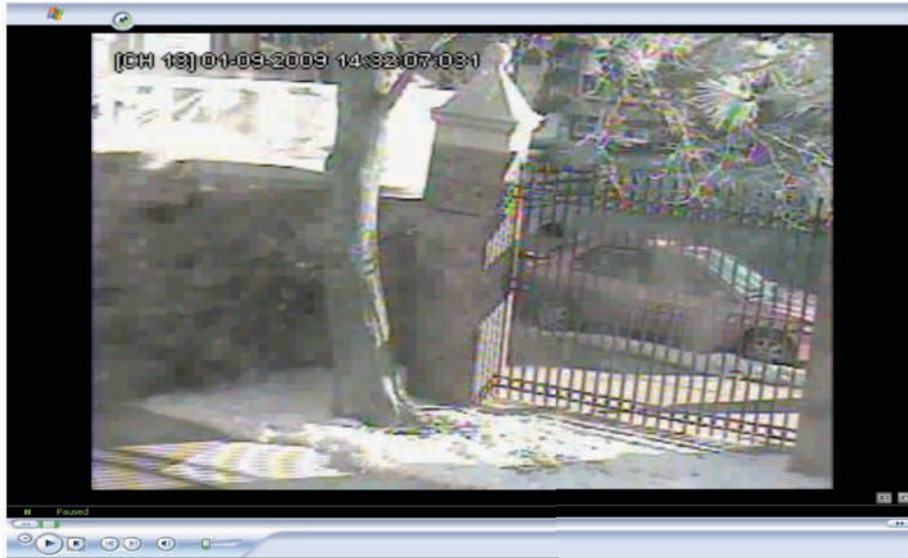
L26 hits two parked vehicles and brick wall.

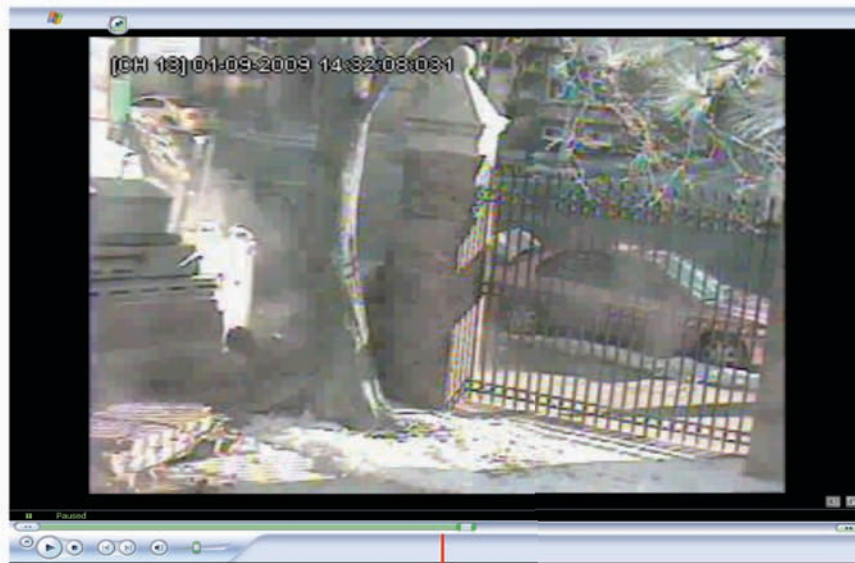
L26 hits high-rise building located at
25 Mission Park Drive.

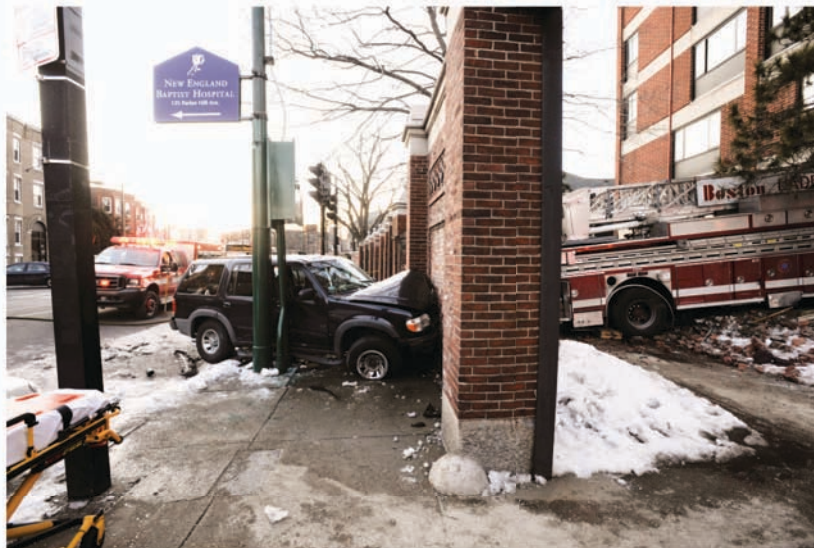
Damage to parked car, brick masonry wall and high-rise building.

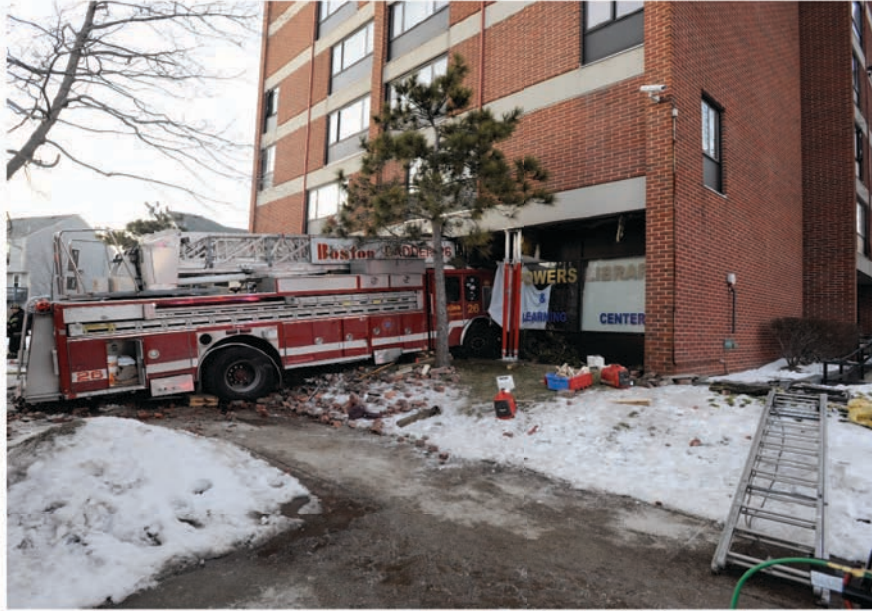
Passenger side view of L26 lodged into high-rise building at 25 Mission Park shows aerial ladder supporting lintel beam.

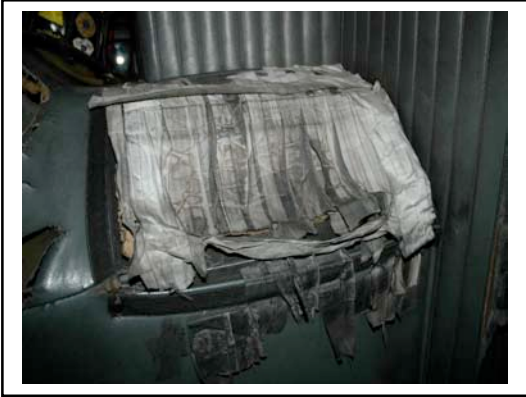
Photo 4

NOTE: The Board believes that these conflicting accounts may have in fact been attributable to the inordinate amount of noise that was permeating from the engine housing. Located in the center of the apparatus' rear passenger compartment where the open-up and roof man were sitting, the engine housing was missing a diamond plate hatch door that had been covered with cardboard and medical adhesive tape to protect the opening (See Photo 4). As a result of this

repair, which in effect magnified the engine noise, both firefighters freely admitted that it was difficult to hear what Lieutenant Kelley and Ladder 26's driver were actually saying to each other.

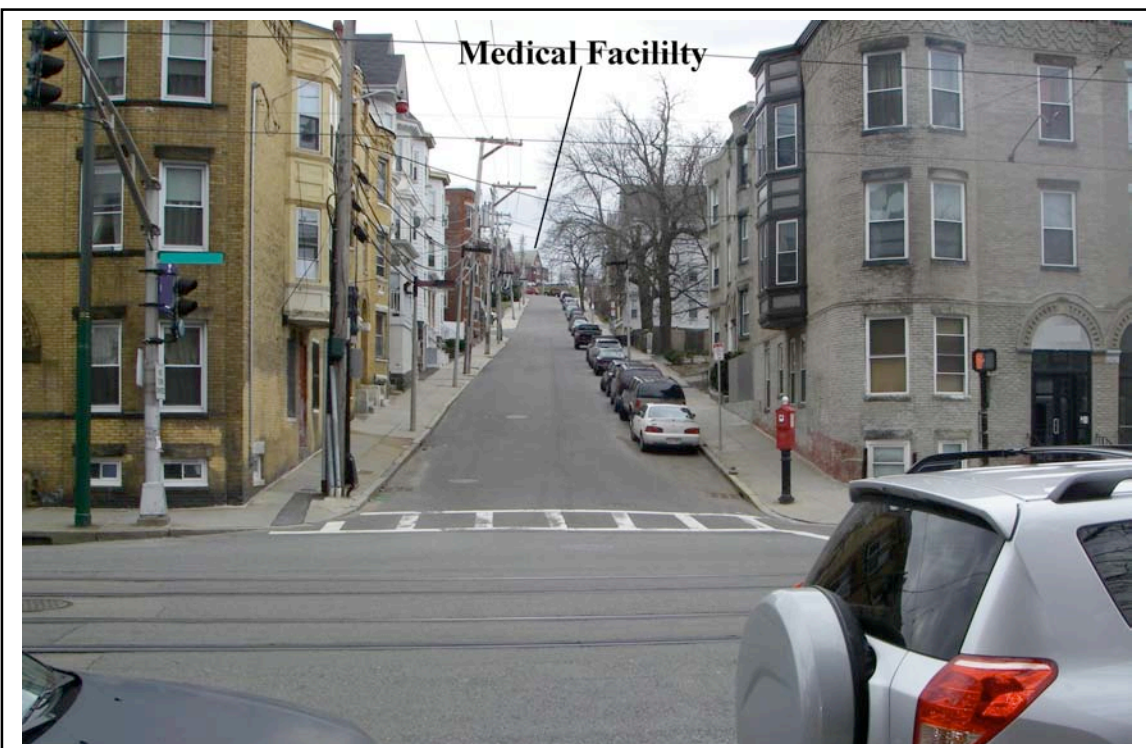
Photo 8

NOTE: According to the Boston Police Department Accident Reconstruction Team Report, Parker Hill Avenue had a posted speed limit of 25 miles per hour (mph) and a 13 % downward grade. Preliminary estimates indicated that L-26 had accelerated to an approximate speed of 57 mph and that approximately 20 seconds had elapsed from the time it descended down Parker Hill Avenue and struck the building at 25 Mission Park Drive. (See Photo 8).

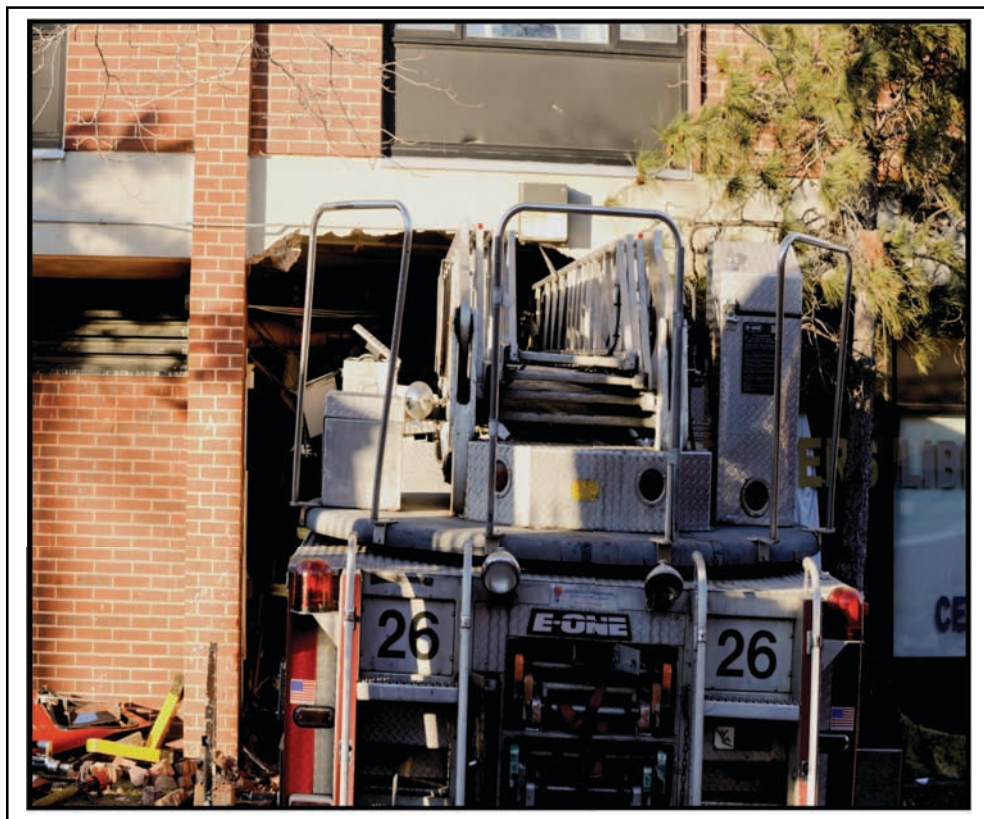
Photo 9

Upon impact, the front tip of Ladder 26's metal aerial ladder pierced a wooden panel at the top of the glass wall and then protruded up and through the ceiling, where it displaced a lintel support beam and compromised the building's service utilities. This included a severed sprinkler system pipe, which immediately started discharging a steady stream of cold water on the apparatus. Fortunately, once Ladder 26 stopped, it had entered approximately four to six feet into the building, and its aerial ladder provided a makeshift shoring system that in effect acted as a support beam, carrying both the wall and ceiling load. (See Photo 9).

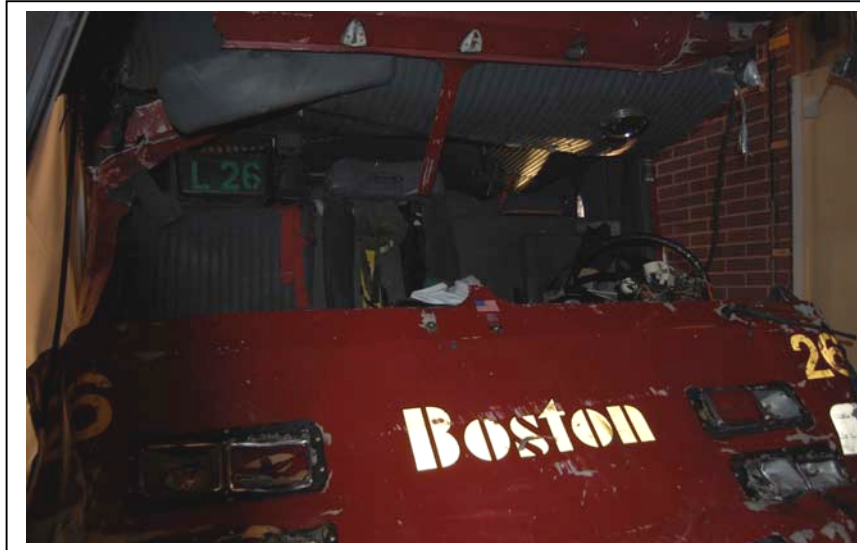
Photo 10

In addition to the building damage described above, Ladder 26 also sustained a bent aerial ladder tip, a broken windshield, a butterflied steering wheel, a sheared off air dryer and driver's side door, a crushed front bumper and a front cab that was bent approximately two feet inward facing the apparatus' driver and front passenger seats. (See Photo 10).

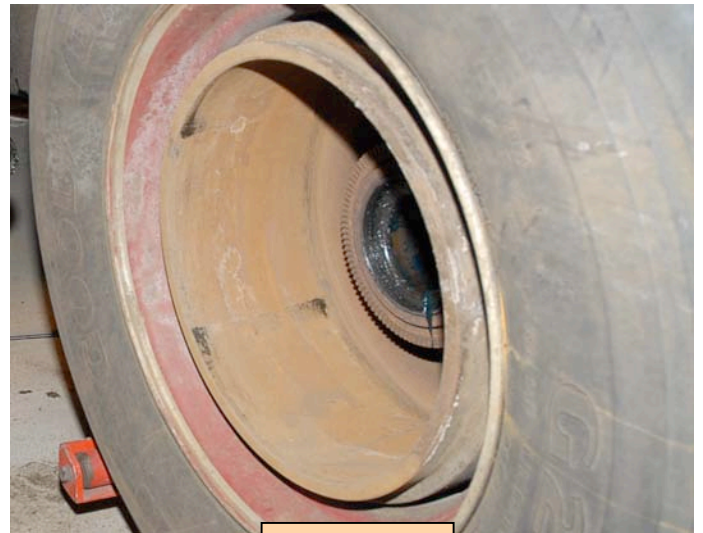
Photo 15

The forensic analyst retained by the DA's Office noted that the left rear brake was covered in rust. (See Photo 15)

*"The interior of brake drum was covered with rust and was pitted. It showed absolutely no signs of wear. The brake shoes appear that they have never been used.....Prior to the accident, it is apparent that a brake job had been done by a person or persons unknown and the brake at this location might have worked for a few applications and then never worked again."*¹

"The left rear drum was completely rusted with rust flaking off the braking surface. This indicates that the brakes were not touching the drum on the left rear wheel." He also made note of the following: *"We would have expected to see much more wear and overheating on the right rear brake linings since the left rear was not braking at all."*⁵

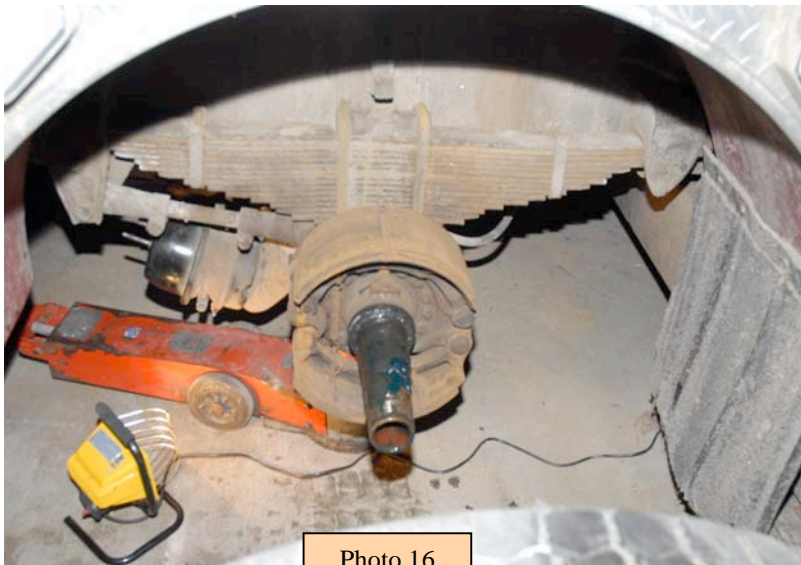
Photo 16 shows that the left rear leaf springs and air chamber were covered in rust as well.

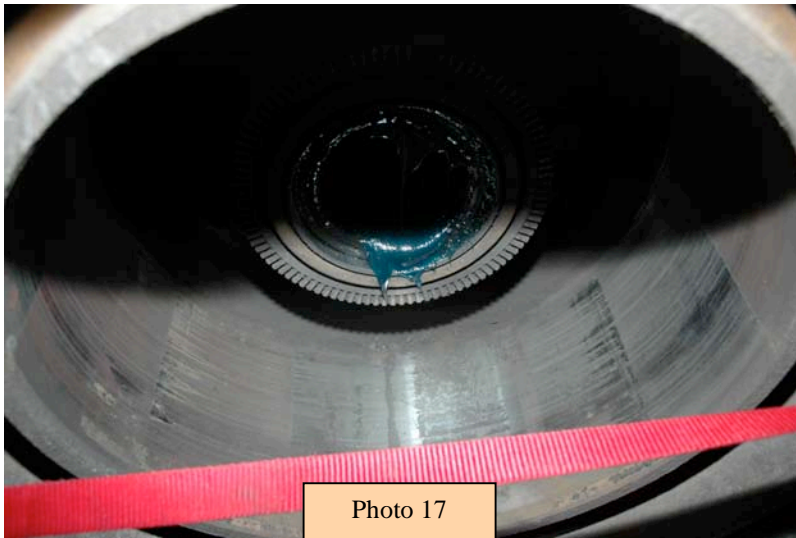
The forensic analyst retained by the DA's Office did not mention rust on the right rear brake in his report. (See Photo 17).

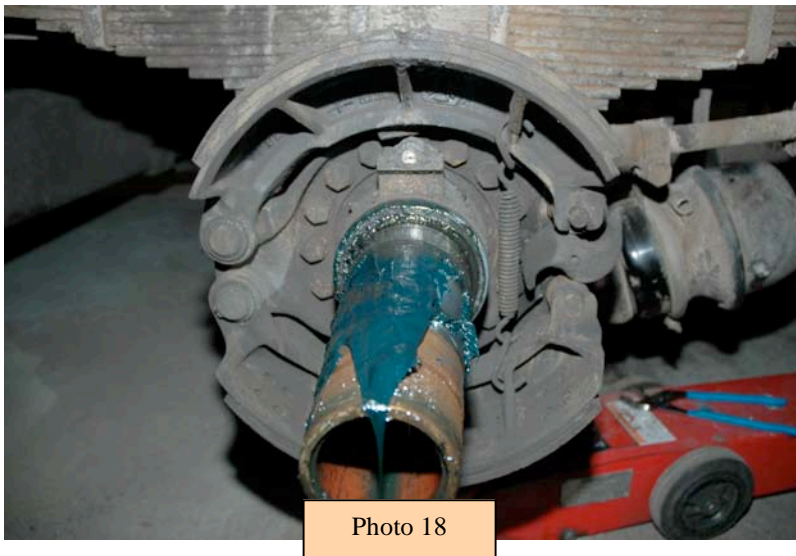
Photos of the right rear leaf springs show lesser amounts of rust. The right rear air chamber shows no signs of rust. (See Photo 18).

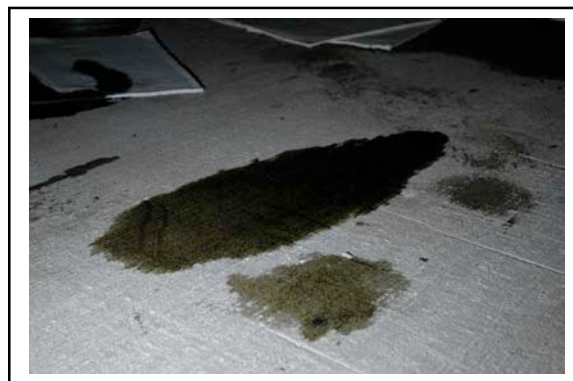
Photo 19

During the clean up of the accident area on January 10, 2009, a valuable piece of evidence was not recovered. This piece of evidence was a part of the air brake system, dislodged from under the front bumper of L-26, and is referred to as an “air dryer.” The purpose of the air dryer is to remove moisture from the air brake system. Maintenance records indicate the last time the desiccant cartridge on the air dryer was changed was on March 10, 2006, making the cartridge 2 years and 10 months old. As stated below in *Section IX, Item #13 of Findings and Recommendations: Rules and Regulations*, air tanks on BFD apparatus had not been routinely drained, and L-26 was no exception. The Boston Firefighters' Local 718 independent analyst observed and noted in his report: “The air tanks were inspected and when the petcocks were removed from the tanks, a black oily liquid puddled on the floor.”¹² (See Photo 19). Due to damage to the air system incurred during the accident, the air supply on L-26 was depleted.
