BOARD OF INQUIRY REPORT
LADDER COMPANY 26
INC# 09-1897
JANUARY 9, 2009

Report on: The Fatal Motor Vehicle Accident Involving Ladder Co. 26
Incident # 09-001897
25 Mission Park Drive
Roxbury, MA
District 5, Division 2

Fire Commissioner Roderick J. Fraser Jr. appointed a Board of Inquiry on January 15, 2009 to investigate the circumstances surrounding the death of Fire Lieutenant Kevin M. Kelley, Ladder Company 26 Group 4, which occurred on January 9, 2009.

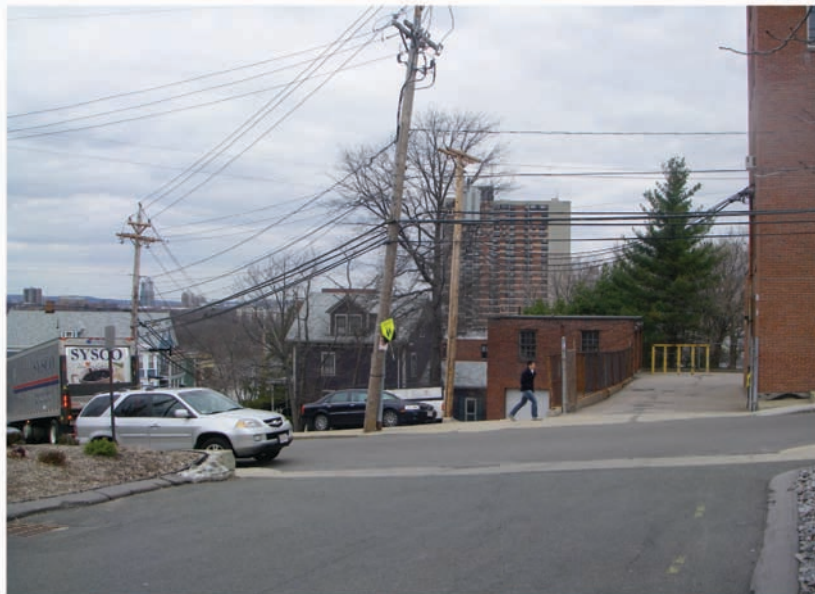
L26 makes three point turn at pole.

(Note: L26's brakes were functioning properly at this time.)

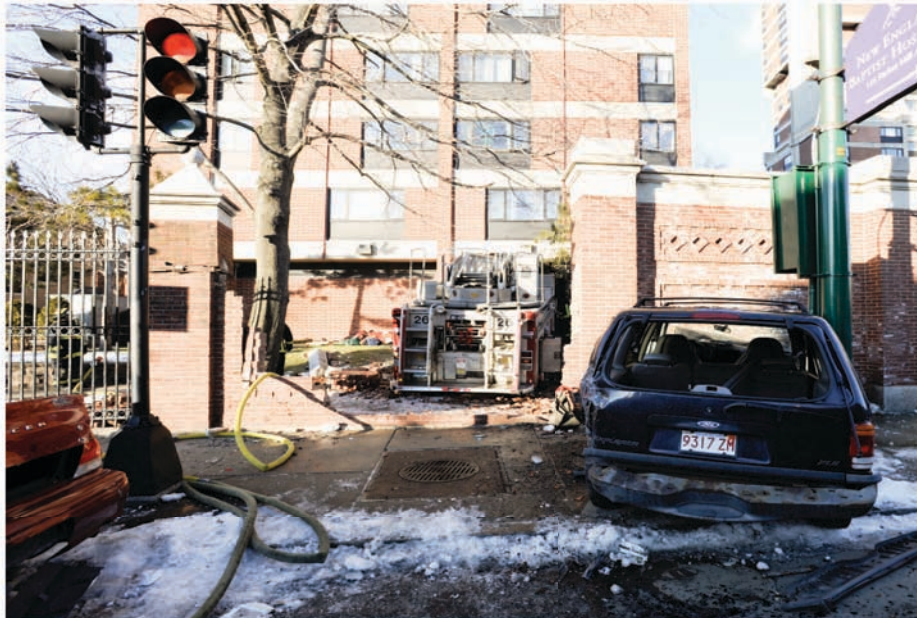
Rear view of L26 lodged into high-rise building at 25 Mission Park Drive.

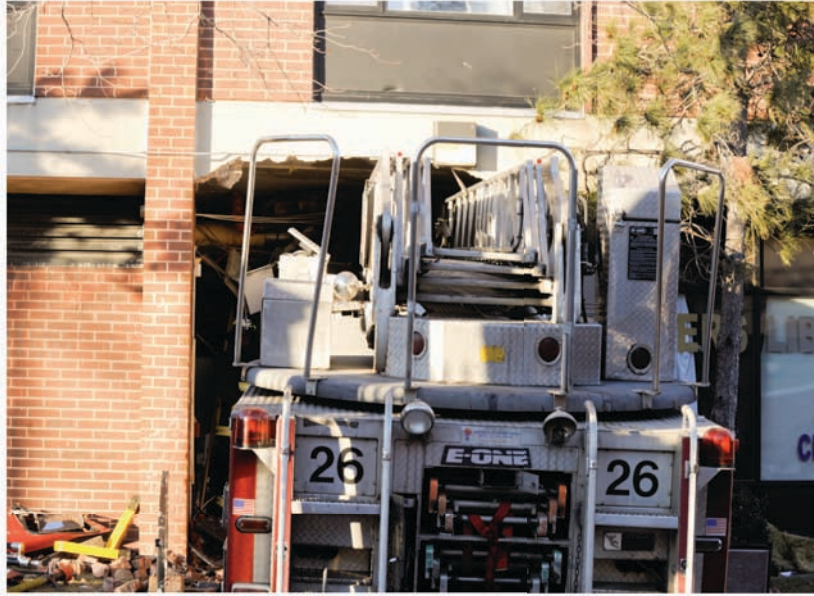
Rear view of L26 lodged into high-rise building at 25 Mission Park Drive. 19

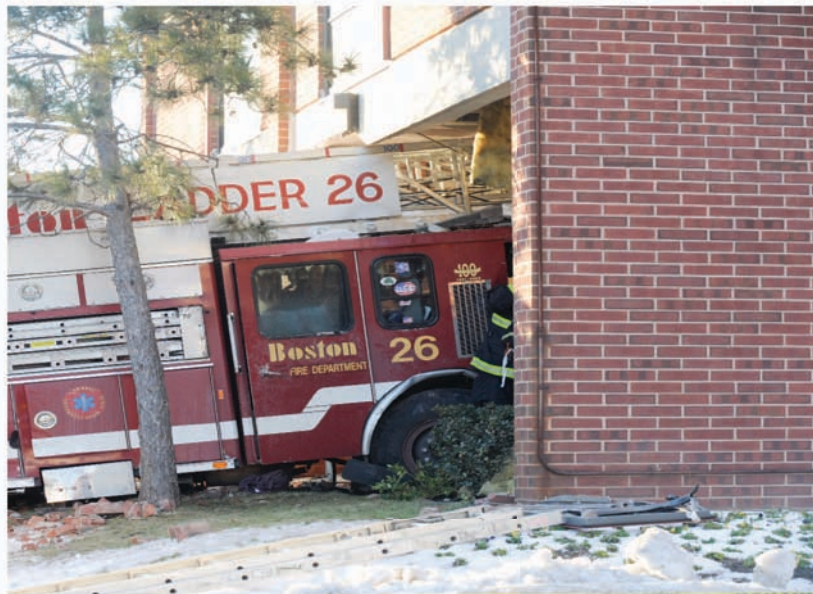
Passenger side view of L26 lodged into high-rise building at 25 Mission Park Drive. 20

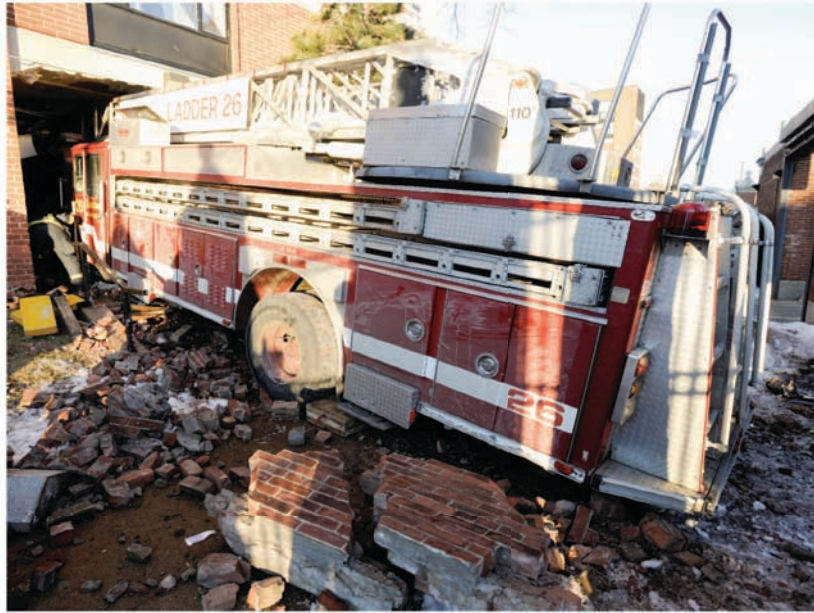
Driver side view of L26 lodged into high-rise building at 25 Mission Park Drive.

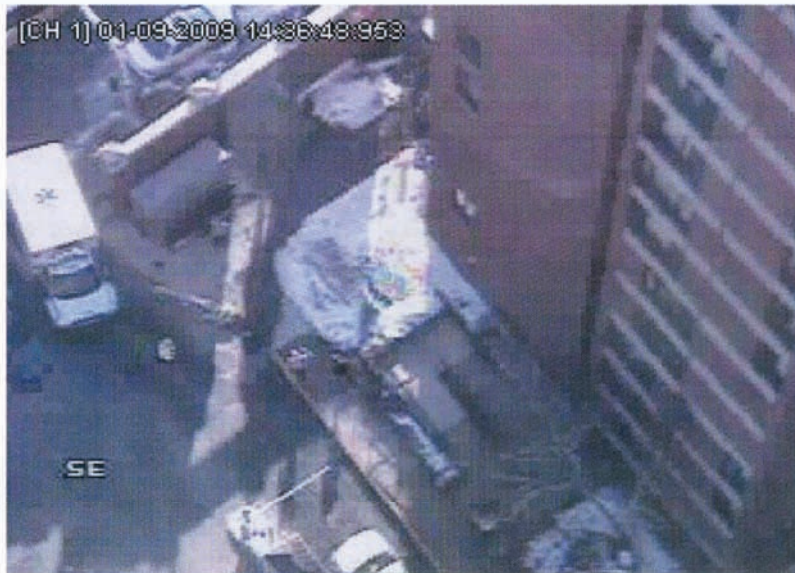
Aerial view of accident site at 25 Mission Park Drive.

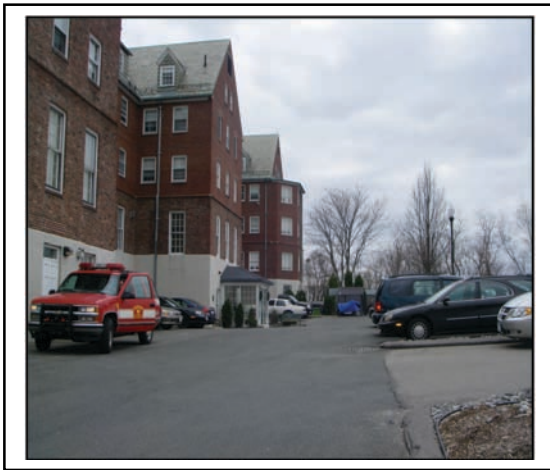
Photo 1

At 1405 hours Ladder 26 was dispatched from quarters by the FAO to respond to 63 Parker Hill Avenue for a “difficulty breathing,” medical assist call. Upon arriving at the Landmark Senior Living Community at 1410 hours, Fire Lieutenant Kelley instructed Ladder 26’s driver to turn the apparatus around in the parking lot, so it would be facing out toward Parker Hill Avenue. Fire Lieutenant Kelley, the roof man, and the open-up man then left the apparatus together to attend to the medical assist call. (See Photo 1).

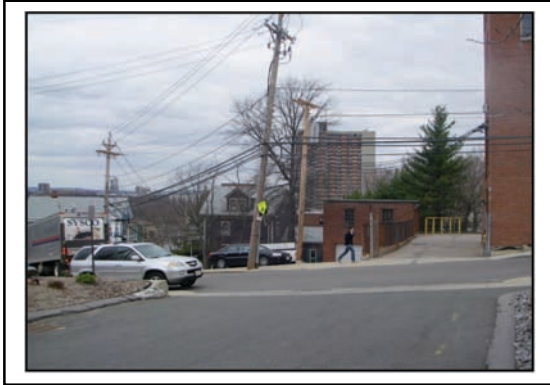
Photo 2

At approximately 1431 hours all Ladder 26 members mounted the apparatus and prepared to return to quarters. Upon leaving the parking lot and turning slightly to the left, the driver sighted a parked car on his left hand side and a utility pole located directly in front of him, on the opposite side of 63 Parker Hill Avenue. (See Photo 2). After determining that he needed to negotiate a three-point turn to clear it, the driver came to a full stop at the pole, shifted the apparatus into reverse, and backed up about one foot. Upon coming to a full stop, he then shifted the truck back into drive and maneuvered it along a right hand, downward curve before proceeding down Parker Hill Avenue. (See Photo 3). According to Ladder 26’s driver, he negotiated the three-point turn on a slight decline and the truck’s brakes were functioning properly at this time, although he could not recall hearing an accompanying release of air after applying then releasing the brakes.

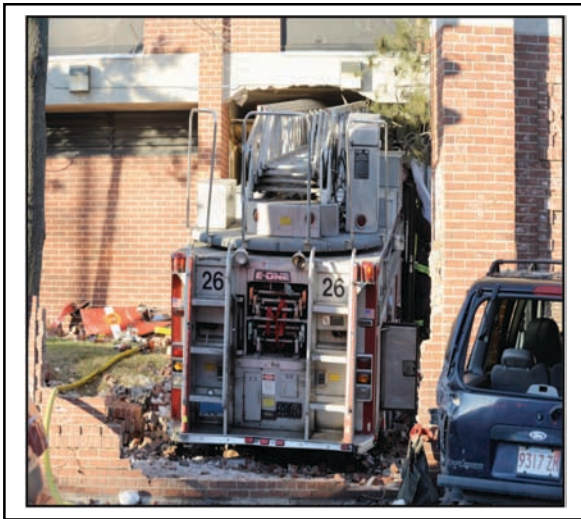
Photo 5

As Ladder 26 reached the bottom of Parker Hill Avenue, it proceeded to cross a four-lane traffic and trolley intersection at Huntington Avenue, strike two parked vehicles, knock down an eight-and-a-half foot high, three course thick brick masonry wall, careen up and over a concrete stair embankment, and crash into a ten foot high glass facade wall. Ladder 26 eventually came to rest inside of the first floor of a 14 story, residential apartment building at 25 Mission Park Drive. (See Photos 5, 6, and 7) According to a number of witnesses, seven children were in the Betty Powers Computer Learning Center on the first floor at this time, participating in an after school program.

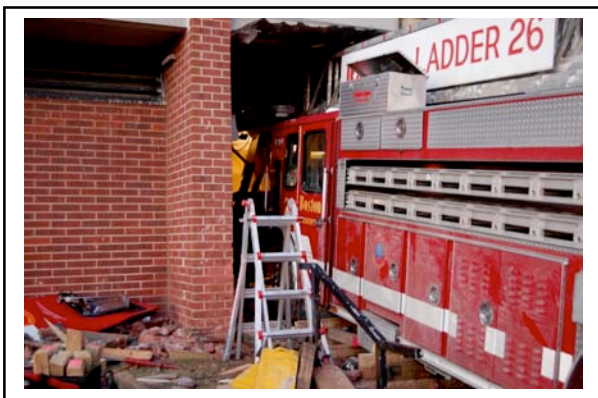
Photo 11

Members of Engine 37 immediately moved to the front of Ladder 26 to check on the condition of the driver and officer, who were both positioned in the front seat. (See Photo 11). A FF from Engine 37 went to the driver's side to check on his condition. The FF then informed his Captain that the driver was trapped and that the officer, Lieutenant Kelley, was seriously injured.

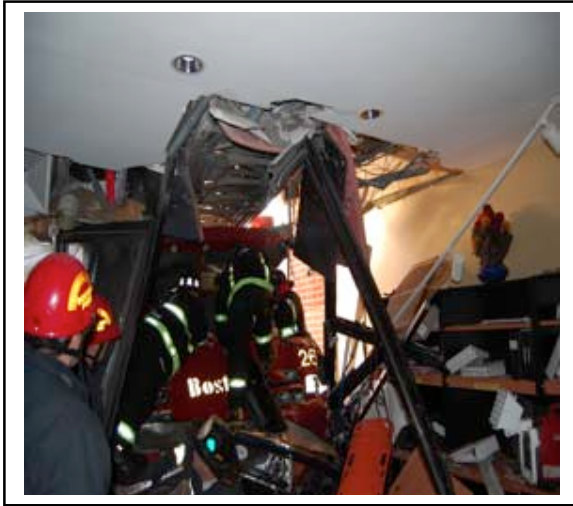
Photo 12

At approximately 1450 hours the District 9 Chief notified the IC that a BEMS paramedic had officially pronounced Lieutenant Kelley. Upon receiving this information, the IC directed all BFD resources toward extricating Ladder 26's driver. (See Photo 12).

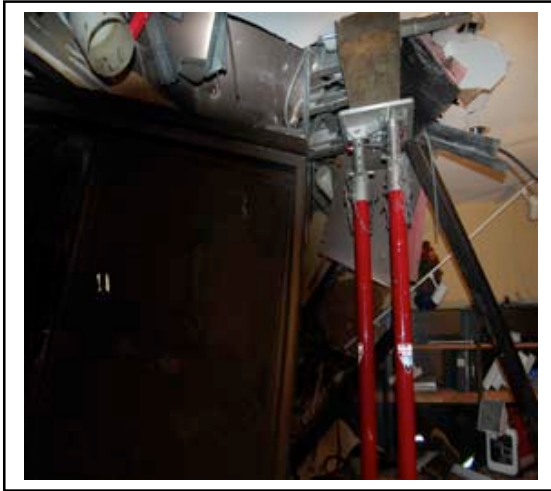
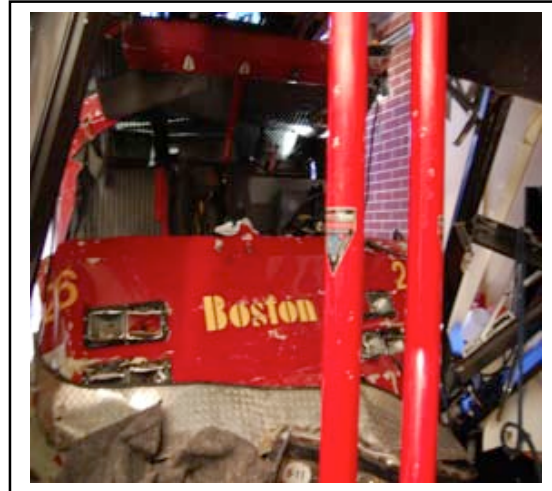
Photo 13

At this point the incident became a recovery effort to remove Lieutenant Kelley from the collapse zone. During this time, other Technical Rescue Units arrived on the scene. This included H-1 (Safety Chief), Engine Companies 28 and 10, Tower Ladder Companies 10 and 3 and H-6 (Collapse Support Unit). Upon arrival, all Technical Rescue Units were respectively ordered by the IC to stabilize the exterior wall and interior of the building with specialized shoring and cribbing, establish a collapse zone and shut down the building's services. Shutting down the building's services required additional manpower to check all elevators and to rescue any trapped occupants. (See Photos 13 and 14).

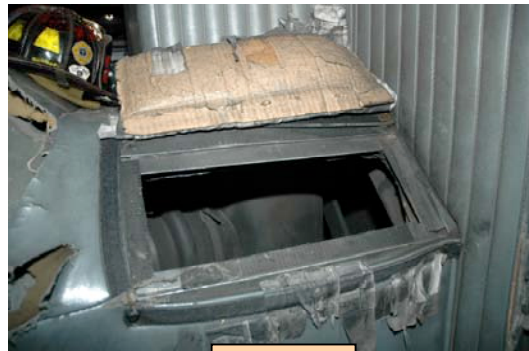
Photo 20

Preventive maintenance (PM) plays a significant role in the length of time a piece of fire apparatus is able to remain in service. PM of fire apparatus exists on the Boston Fire Department (BFD), but not to the specifications recommended by the manufacturers. As a piece of fire apparatus ages, PM becomes more important in its overall operational reliability. A PM program must be comprehensive. As a piece of apparatus ages, certain items that break or wear out may have not been replaced for reasons of cost. For example, on Ladder 26 (L-26), part of the engine cover, adjacent to the rear right seat, was covered with cardboard and held in place with medical adhesive tape (See Photo 20).

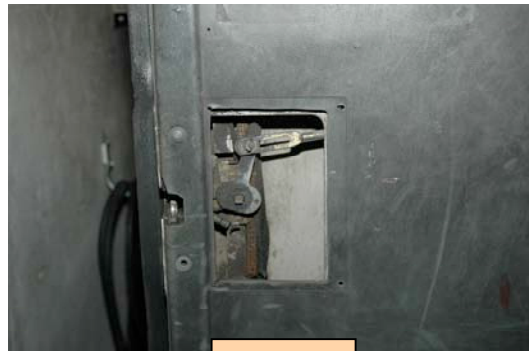
Photo 21

According to the report written by the expert forensic analyst retained by the Suffolk County DA's Office: *"Pre-existing deficiencies noted during the inspection of the vehicle subsequent to the crash of January 9, 2009, included an inoperative left rear passenger door latch (See Photo 21) and severely rusted-through protective steel enclosure for electrical system components."*⁴⁴ The report also made note of: *"...strikingly evident exhaust leak at the muffler/tailpipe junction, as well as at the tailpipe due to the presence of a significant rust hole."*⁴⁵

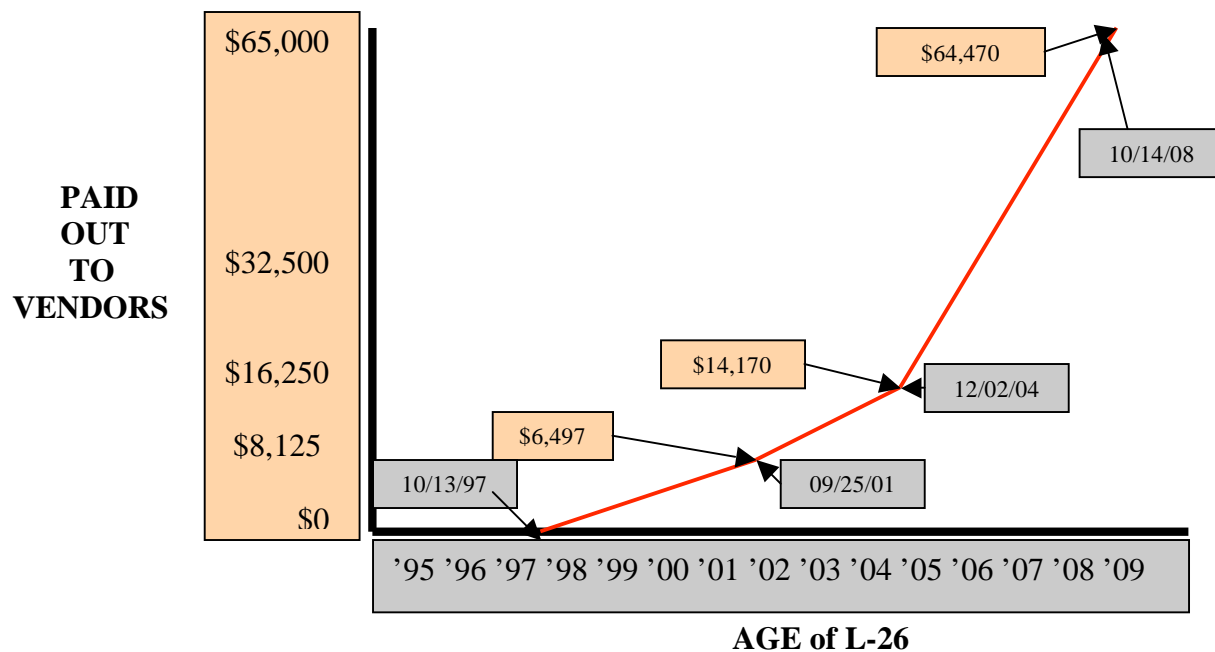
On the date of the accident, Ladder 26 (L-26) was 13 years and 6 months old. The first record of maintenance provided by an outside vendor was on October 13, 1997; L-26 was 2 years and 3 months old. By September 25, 2001 when L-26 was 6 years and 2 months old, the BFD had paid outside vendors a total of \$6497.00. From that date until December 2, 2004, a period of 3 years and 3 months, when L-26 was 9 years and 5 months old, an additional \$7673.00 had been paid to outside vendors. From December 2,

2004 until October 14, 2008, a period of 3 years and 10 months, when L-26 was 13 years and 3 months old, an additional \$50,300.00 had been paid to outside vendors. Nearly 43% (\$28,024) of the total funds (\$64,470) were expended in the last 2 years. (These figures do not include the additional costs expended at the BFD shop for maintenance items such as tires, batteries, light bulbs, air filters, fuel filters, oil filters, oil changes, lubrication etc. These figures also exclude the costs of an outrigger repaired due to an accident. These figures do include the costs for body repair for an accident on 08/22/06, a consequential cost due to brake failure). When taking into consideration the added cost of the manufacturer's recommended preventive maintenance, had it been performed per schedule, these figures would be considerably higher.

In order to be certain that all front-line and reserve fire apparatus in service on the BFD meets a minimum standard, The Board recommends:

12.1 That all fire apparatus be maintained to the appropriate sections of NFPA 1911 Standard for the Inspection, Maintenance, Testing and Retirement of In-service Automotive Fire Apparatus, 2007 Edition,⁵³ and to manufacturer's specifications.
